SUBJECT: Inner Booms

MODELS: ALL ETNF AND EST46NF MACHINES**

SERVICE BULLETIN REF. 061101

DATE: January 2011 (re-issued)

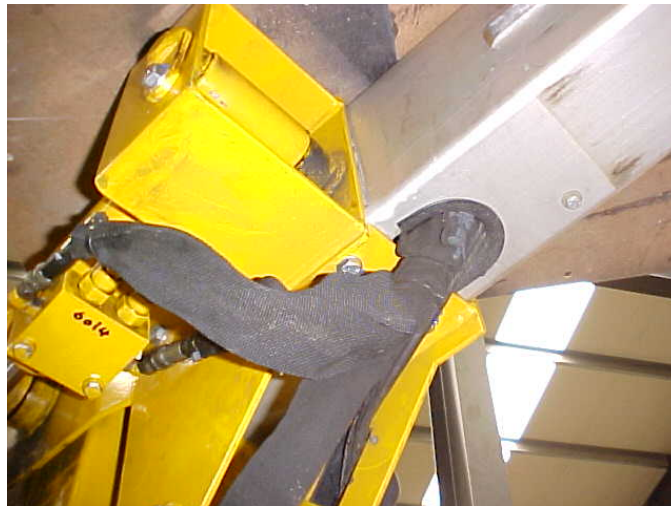
In a small number of cases it has been found that the inner boom on ET machines that have been subjected to excessive stresses, due to overloading or impact, may show signs of stress cracking in the area of the hose and cable entry hole in the underside of the boom. This area of the boom should always be carefully examined during a thorough examination to ensure no signs of stress cracking are present. In the event that stress cracks are present then the inner boom must be replaced as it is not possible to carry out any welding repairs on this boom. In the event of any uncertainty about stress marks in this area please contact Versalift Service for advice.
