SUBJECT: ET main boom pivot boss fillet weld cracks (2010 model ->)

SERVICE BULLETIN REF. 13/1001

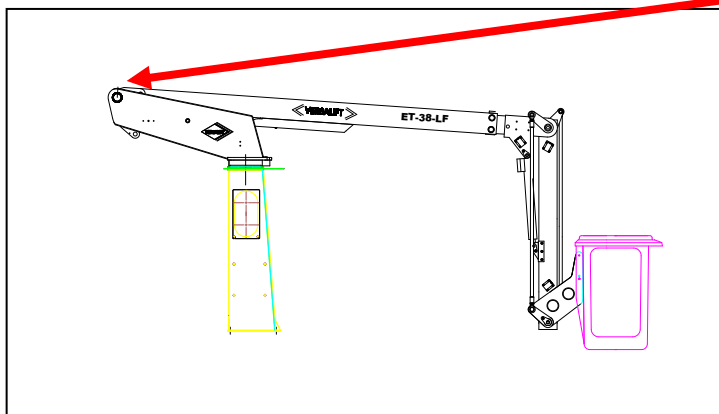
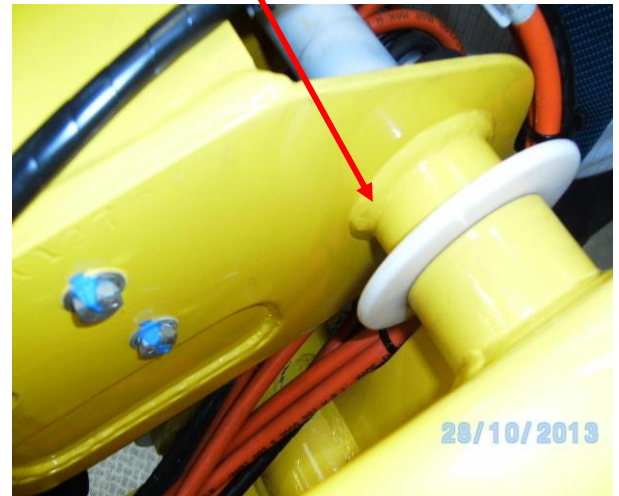
It has recently been brought to our attention during a routine service inspection of an ET machine evidence of a crack at the main boom pivot boss fillet weld.

The bosses concerned are welded to the sideplates of the main boom fabrication. However, please note that weld undercut or cold lapping can often be mistaken for a crack and any concerns can be clarified by the use of Dye Penetrant Inspection (D.P.I) techniques.

Any concerns should be reported immediately for repair/replacement advice (depending on age of machine). Please ensure that you supply the Serial No of the machine when reporting your findings.
