ETM Pressure – return hose routing issue

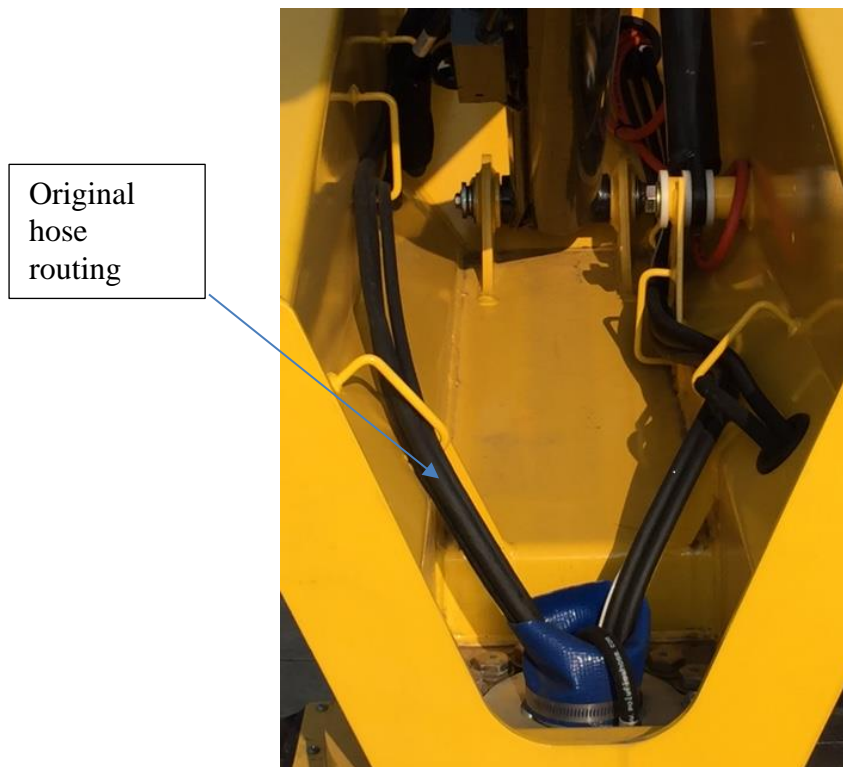
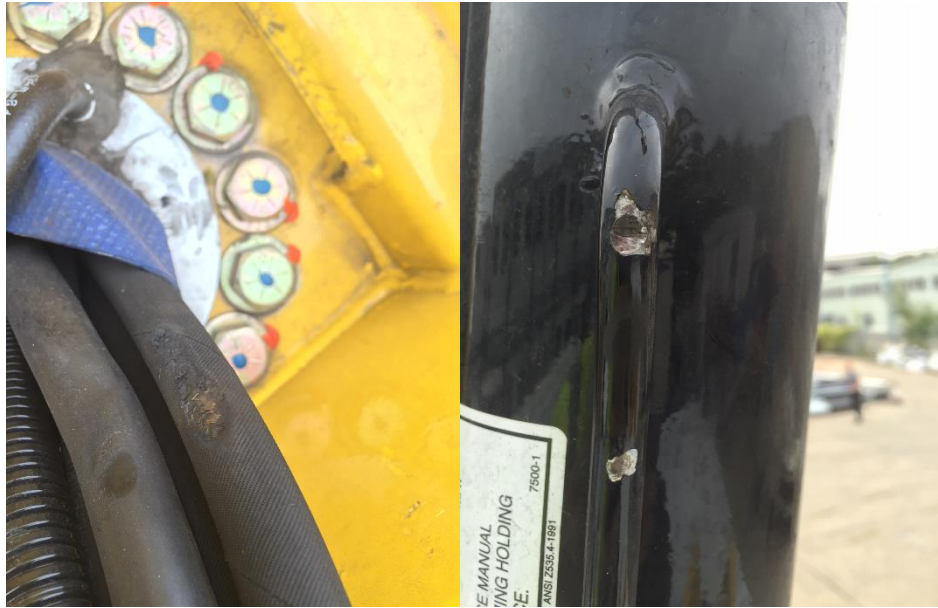
We have an issue where the pressure and return hoses from the pedestal valve to the turret valve are routed in such a way that it wears away the protective rubber from the hose, exposing the metal braid which in turn wears the steel pipe on the side of the main lift ram. The pictures below show both issues.

We can engineer away this issue by routing the two hoses on the other side of the turret. The pictures below show the routing and with the addition of one P clip secure them into position.
