SERVICE BULLETIN: Fly-boom head stock EO400-401 Issue 2

FLYBOOM 120° FOR ETL
L3
VERSION 2016

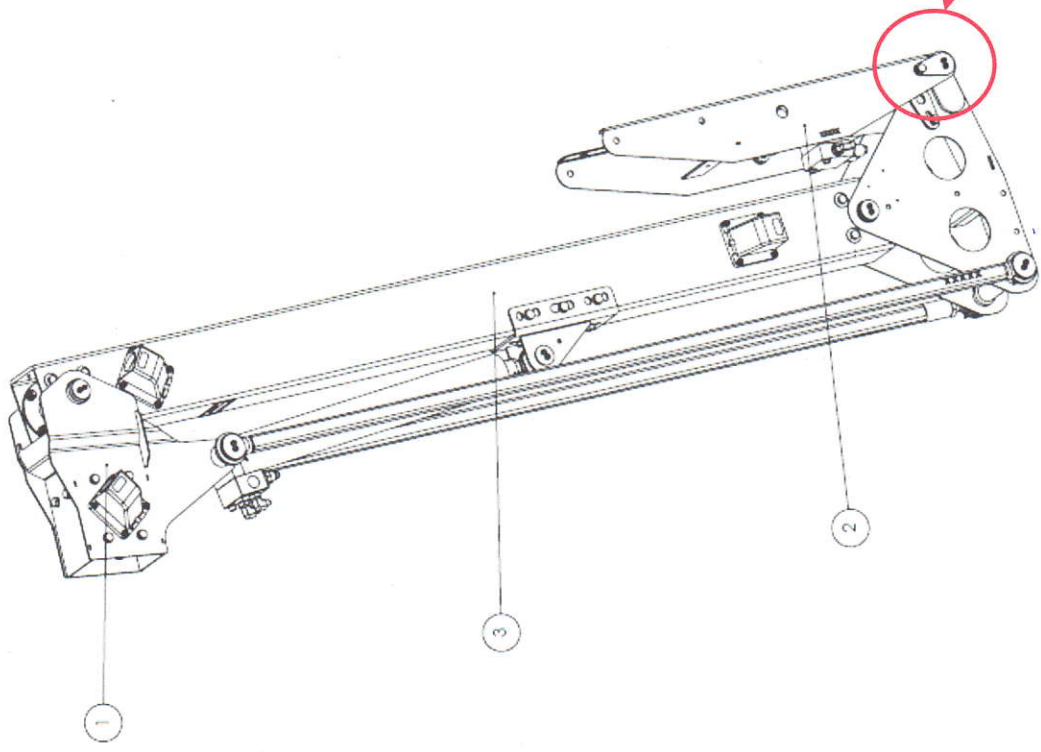
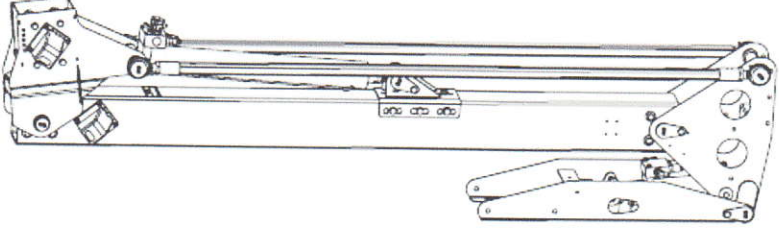
In-service wear/ cracking has been detected on the bucket bracket at the lower pivot point (circled in red on page 2). This may affect the lifts listed below:

Operators of the lifts listed above are to immediately, upon receipt of this Service Bulletin, inspect the bucket bracket (Item 2 overleaf) for signs of wear/ cracking around the lower pivot point. If there are signs of wear, please remove the vehicle from operation and report your finding to the contact detailed below.

A Versalift in-service inspection/ modification will be carried out to all lifts, as listed above, within 1 month of the date of this Service Bulletin. The Versalift Service team will contact you in due course to schedule these works.
