**Service Bulletin: LAT-160F (serial numbers 2013-2015)**

**Date of issue:** 6<sup>th</sup> June 2019

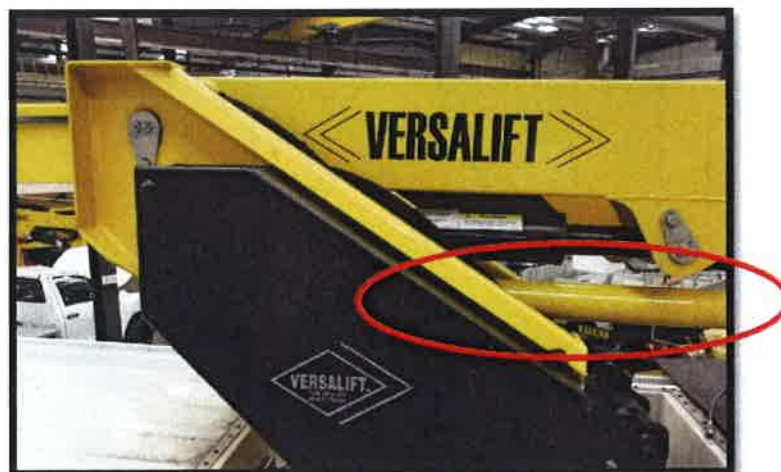
The initial investigation for vehicles manufactured between 2016-2019, instigated during routine maintenance, showed that there may be bearing seizure at the lower end of the compensating link rod, shown in *Figure 1*.

*Figure 1:* LAT-160F Compensating link location.

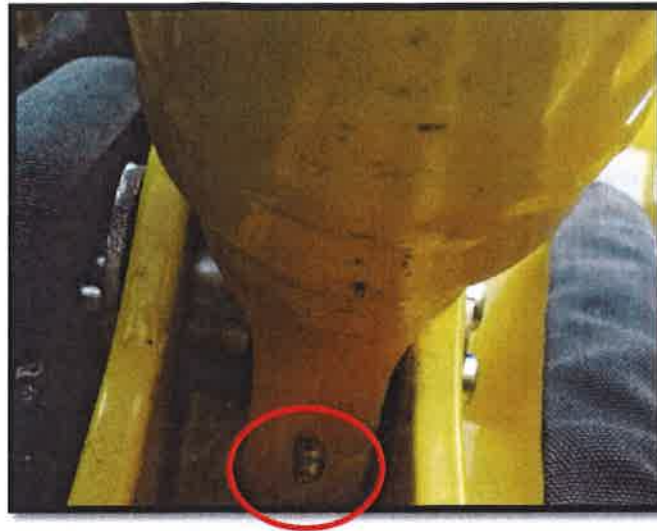
*Figure 2:* Compensating link grease nipple location

To carry out this inspection please check for any sign of damage around the lower compensating link bearing area as shown in *Figure 2*. Specifically, please ensure there is grease between the bearing and the pin; grease should be pumped into the grease nipple, circled below, until excess grease is visible.

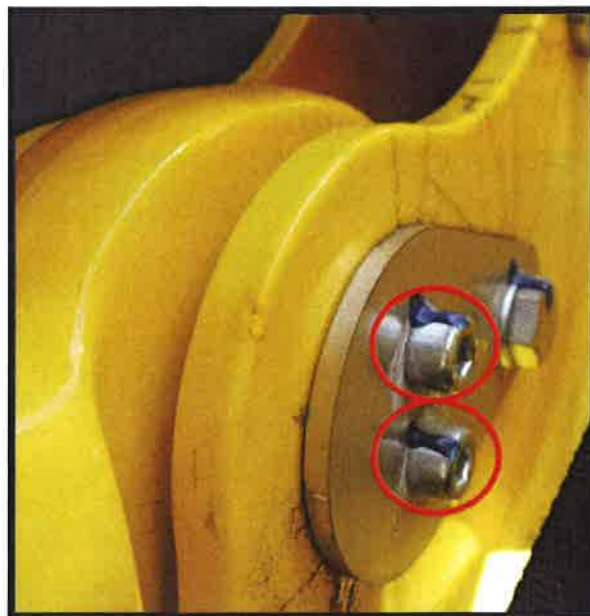
*Figure 3:* Pear shape washer location at lower end of compensating link.

During operation of the lift please check that both retaining plates do not rotate and that there is no excessive play/ movement in the two bolts securing the pear shape retaining plate shown below in *Figure 3*.

Versalift have taken these precautionary measures to reduce any potential risk to its customers and their operators. Due to the critical functionality of this component Versalift ask that this in-service inspection be carried out immediately upon receipt of this bulletin. If any wear or damage is visible, then please remove the vehicle from use and contact the After Sales team.
