Service Bulletin: LAT-160F (serial numbers 2016-2019)

Date of issue: 6th June 2019

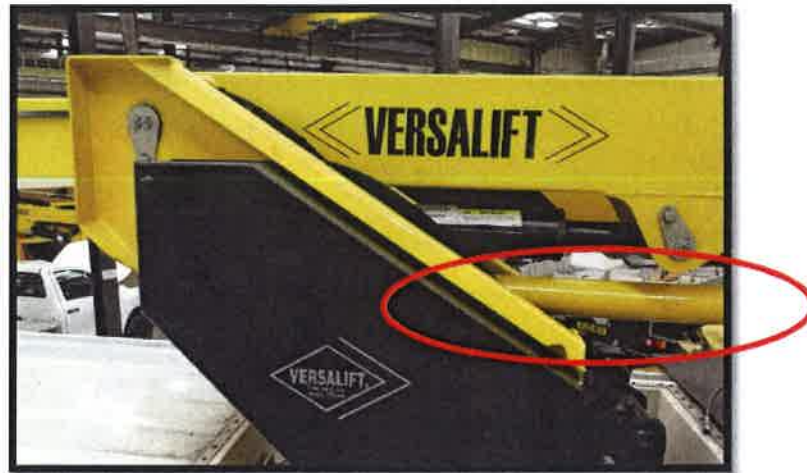
Versalift United Kingdom Limited have identified a potential issue with the LAT-160F lift platform from serial number years 2016 to 2019, this list is shown below in *Table 1*. The initial investigation, instigated during routine maintenance, shows that there may be bearing seizure at the lower end of the compensating link rod, shown in *Figure 1*.

Figure 1: LAT-160F Compensating link location

Versalift have evidenced this hypothesised mode of failure on three individual lifts. As a result, Versalift advise all affected Operators to stand down these lifts, as listed below, with immediate effect until the Service team can attend site to carry out inspections.

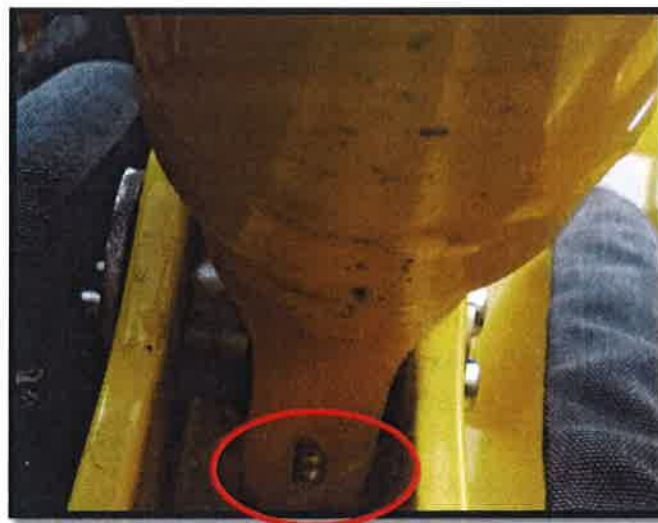
Insufficient lubrication on the lower end bearing, though the grease nipple (location shown in *Figure 2*) has been observed which in turn may lead to pin rotation during lift use. As the pin is designed to be a fixed hinge point under rotation damage may occur to its securing points such as shearing of the bolts on the pear shape retaining plate shown in *Figure 3*.

Figure 2: Compensating link grease nipple location

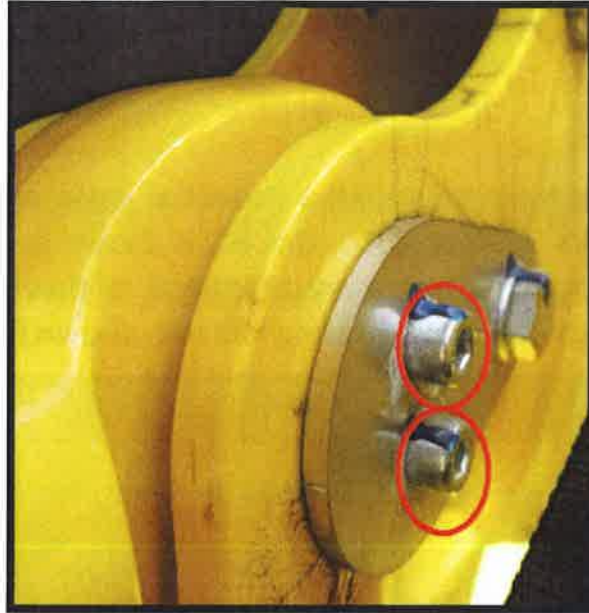
Figure 3: Pear shape washer location at lower end of compensating link.
