SUBJECT: Slip Rings

MODELS: ALL CONTINUOUS ROTATION MACHINES

SERVICE BULLETIN REF. 050503

DATE: April 2005

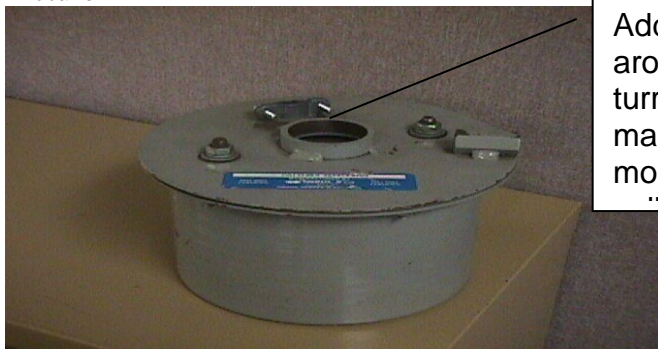
Picture 1

We have received reports that in some extreme “wet” environments there is a potential problem with condensation building up inside collector rings on units mounted with continuous rotation. If any oil is present the mixture of water and oil can mix and cause electrical problems.

Add some silicone around the wires at the turret or top of the rotary manifold to reduce the moisture entering the
