SERVICE BULLETIN NO. SB-7-44400

SUBJECT: LAT-38-135-H rear suspension hanger

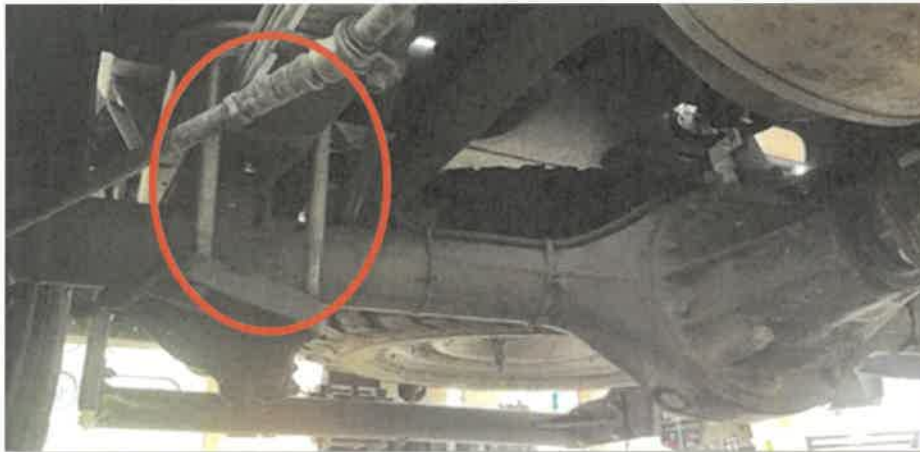
Versalift have been notified of an in-service one-off incident on the LAT-38-135-H pickup installation. During transport the air suspension U-bolt clamps, used to secure the suspension to the chassis and rear axle, have loosened leading to movement between the axle and the chassis.

Versalift ask, that in the first instance, end users inspect the U-bolt clamps to ensure they are secure and that the bolts have not loosened (the torque values for these bolts is 68Nm). If the bolts/ clamps are found to be loose then all work(s) must be stopped and Versalift informed.
