**SUBJECT: Inner Booms**

**MODELS: ALL ET\*\*NF AND EST46NF MACHINES**

**SERVICE BULLETIN REF. 061101**

**DATE: January 2007 (re-issued)**

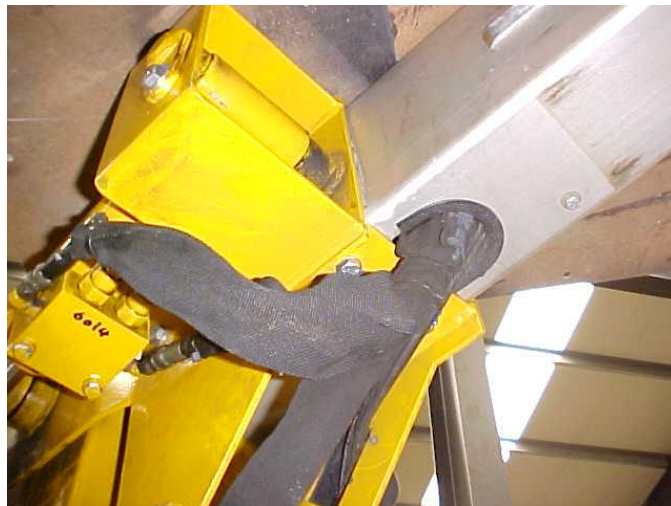
In a small number of cases it has been found that the inner boom on ET machines that have been subjected to excessive stresses, due to overloading or impact, may show signs of stress cracking in the area of the hose and cable entry hole in the underside of the boom. This area of the boom should always be carefully examined during a thorough examination to ensure no signs of stress cracking are present. In the event that stress cracks are present then the inner boom must be replaced as it is not possible to carry out any welding repairs on this boom. In the event of any uncertainty about stress marks in this area please contact Versalift Service for advice.
