SERVICE BULLETIN NUMBER: SB-6-44162

DATE OF REPORT: 27th of November 2020

SUBJECT: Toyota Hilux and Isuzu D-Max LAT-38-135-H E6 Pedestal Bulletin

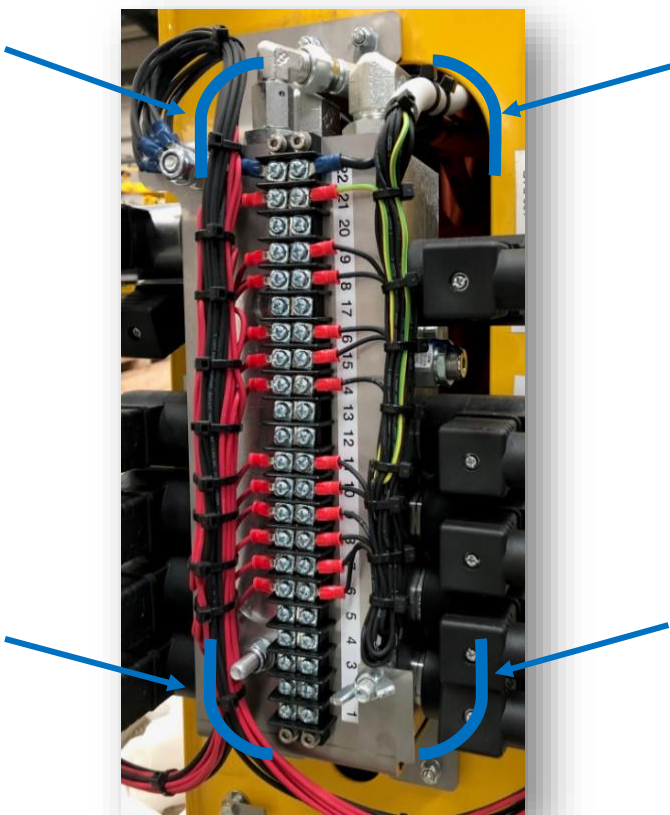
Versalift have identified through routine inspection, in-service reports, and customer feedback the risk of material fracture/ cracking in the pedestal propagating from the valve-bank pedestal oval cut-out radii, as identified in the image below, on the LAT-38-135-H.

This may be attributed to vehicle/ lift mistreatment and misapplication such as overloading however, Versalift ask that in the first instance the end users inspect the areas shown to the left for damage before use.

If cracks, deformation, and/or damage is identified work must be stopped and Versalift informed so that the pedestal can be further inspected.

Further to these checks Versalift have developed a boom rest support to alleviate the potential risk in this area whilst improving the usability, road travel vibration, and bucket docking process post customer feedback.
