# BULLETIN

**SUBJECT: Pin & Bolt Markings on VOE Machines**

**SERVICE BULLETIN REF. 19/0917**

**DATE: 19<sup>th</sup> September 2017**

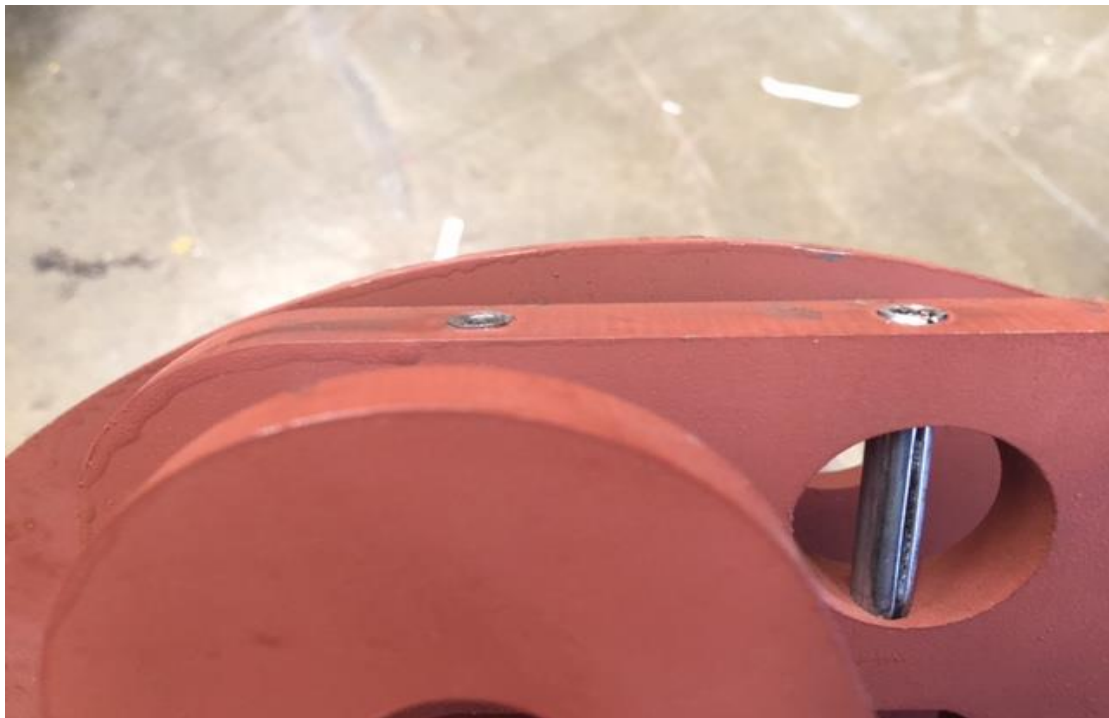
Image above is to highlight how the 2" X 1/4" Spiral Pin should seat in the Quadrant Assembly
