SUBJECT: FWD TRANSIT PUMP / BRAKE LINE LOCATION

SERVICE MEMO. 14-01-23

DATE: JANUARY 2014

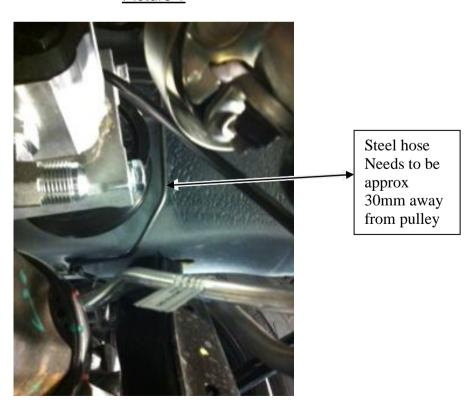
Picture 1

We have had one reported incident that the hydraulic pump fitted to the rear of the engine can come into contact with one of the steel brake lines even though the pump is fitted to the exact same position that Ford fit the air conditioning pump.

We are therefore contacting all our customers who have purchased the Front Wheel Drive Transits and asking them to check the proximity of the steel brake hose to the rear of the pump drive pulley.

We have devised a procedure for relocating and securing the brake line to remove this risk.
