SUBJECT: FWD TRANSIT PUMP / BRAKE LINE LOCATION

SERVICE MEMO. 14-01-23

DATE: JANUARY 2014

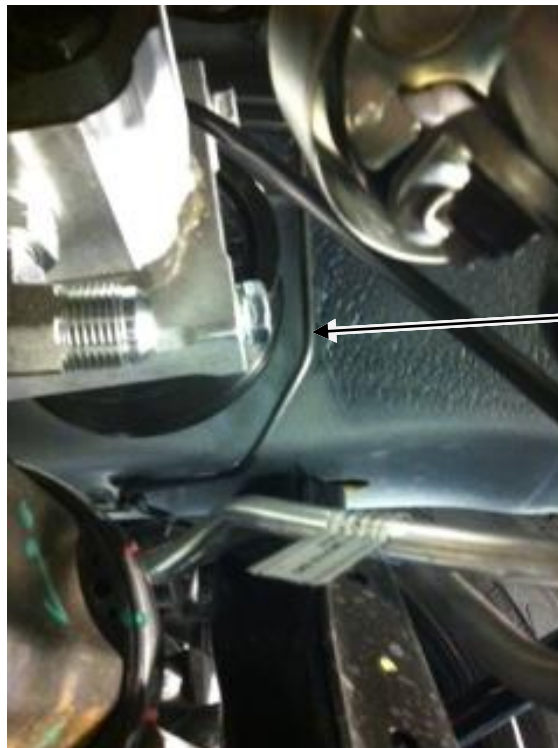
Picture 1

Steel hose
Needs to be
approx
30mm away
from pulley

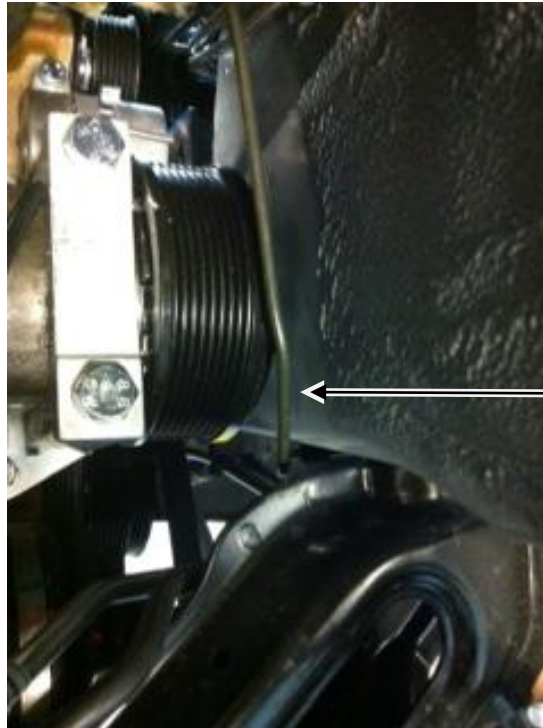
Picture 2

Hose needs pulling away from pulley.

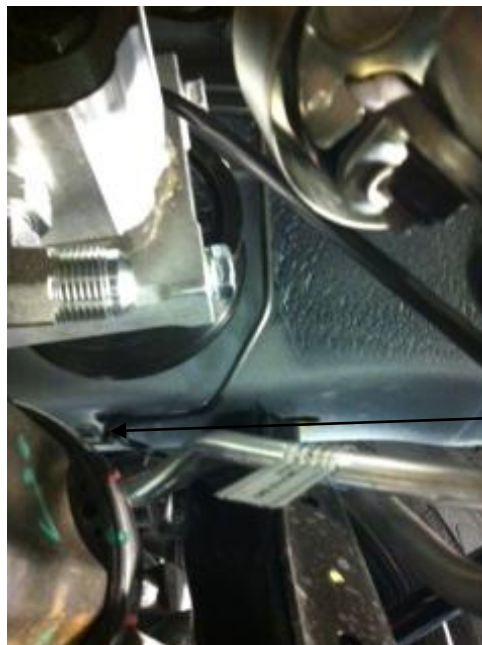
Remove plastic clip

1. Remove plastic clip as shown in figure below, drill hole to 7mm and fit a 5mm nut insert.

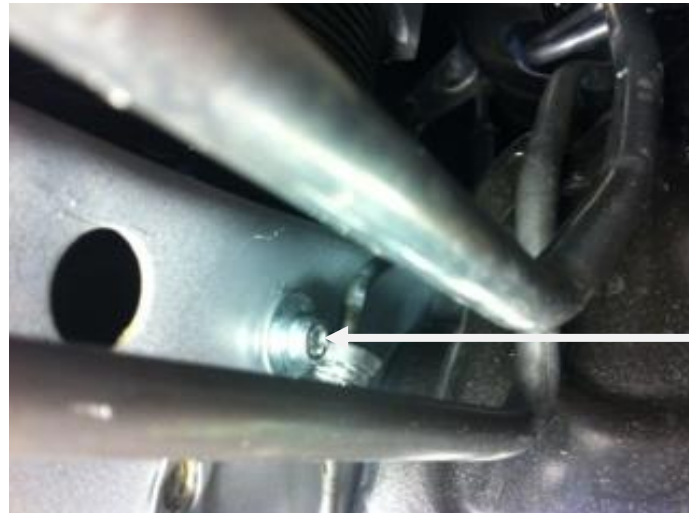
Fit "P Clip"

2. Push pipe to rear of the vehicle away from pulley and fit "P Clip"

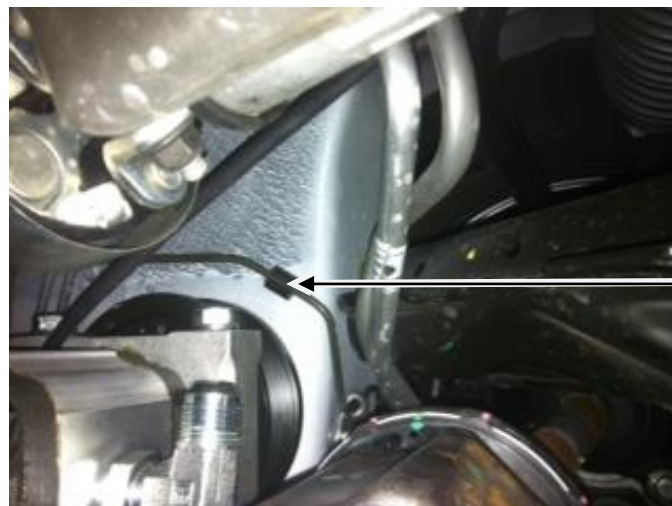
Fit
Grommet

3. Relocate rubber grommet from wheel side of chassis to engine side.
