# BULLETIN

**SUBJECT: Pin & Bolt Markings on VOE Machines**

**SERVICE BULLETIN REF. 19/0917**

**DATE: 19<sup>th</sup> September 2017**

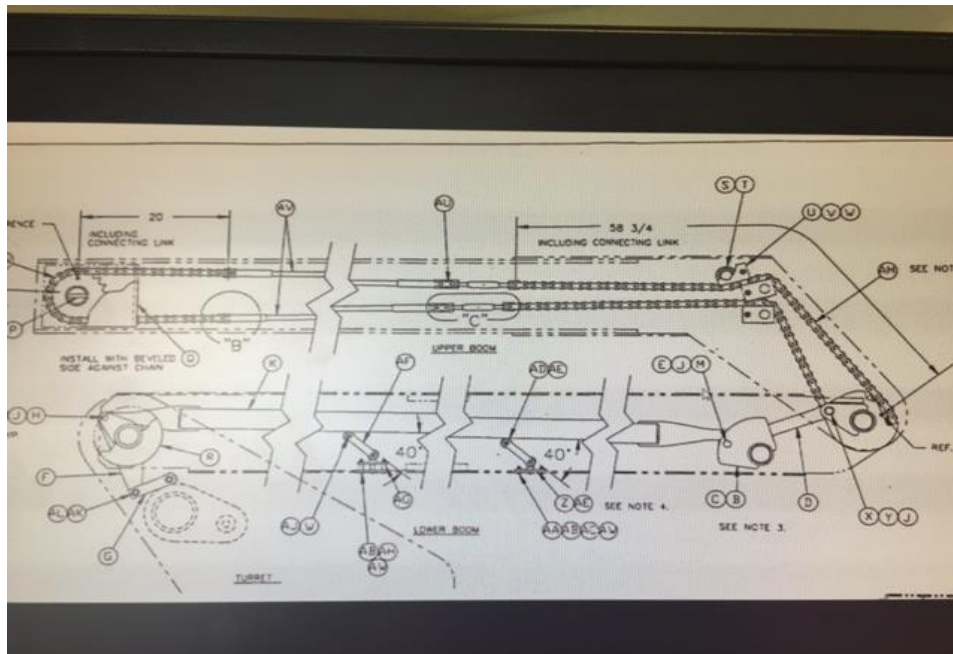
We have had a recent occurrence of a Spiral Pin shearing, causing a Link Pin on the Compensator Link Weldment to come out and tip the 2 Cages back on a VOE Platform.

We believe that this is an isolated incident and not a manufacturing issue, but following this incident, it is now a requirement that all critical fixings inside the Boom Assembly/Compensator Link (Spiral Pins, Link Pins, Nuts, Bolts) are marked up with Torque Seal (84006-2) to assist in monitoring the position of all fixings.

The continuing pages show a photographic breakdown of the areas that need to have the Sentry Seal applied and this should be routinely checked as well as being inspected at every LOLER Examination.
