SERVICE BULLETIN # 117

SUBJECT: Knuckle Repair

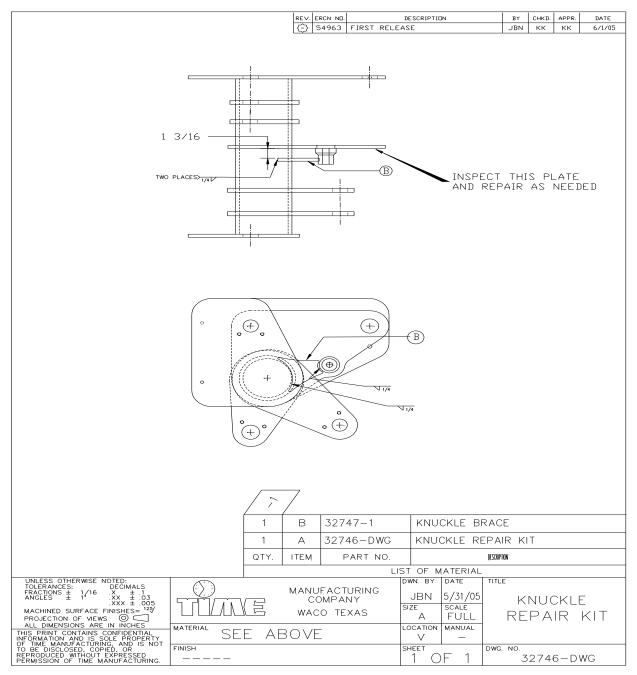
Time Manufacturing has received reports of a crack appearing at the knuckle mounting support where the master leveling cylinder is attached. Please reference drawing, #32746, on the second page.

All targeted units must be identified, located, and inspected to determine if a crack is present at the affected area. If a crack is found, stop-drill the ends of the crack with a 1/8"–3/16" drill bit, v-groove the crack, weld with 7018 electrode or equivalent wire and grind smooth. At this point, add the support bracket, welding as detailed in the drawing. Paint as needed. Should the inspection reveal no evidence of a crack, the support bracket must still be installed. The bracket can be ordered by requesting part number MO-277-1.
