**SUBJECT: ET 26 NEXS Docking Switch Wiring Modification**

**SERVICE BULLETIN REF. 06/0102**

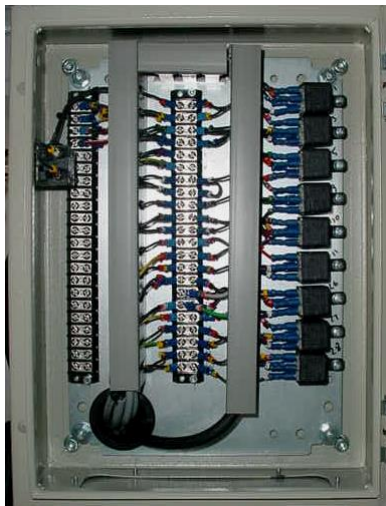
We have discovered a problem with the ET 26 & 30 NEXS machines out in the field; an operator has found that you can defeat the PTO/HANDBRAKE interlock. To overcome this problem minor a wiring change is required on all machines in service.

The wiring change is as follows: - using wiring diagram n°s see note below.  
1. The normally open wire of the docking switch (core n° 1) VDL terminal strip n° 5 found in the pedestal junction box see photograph below

Remove terminal wire n° 5 on the left hand side of the terminal strip and check for voltage using a voltmeter, the wire to be moved is the one **without voltage** on it when checked with the voltmeter, the wire n° 5 that has voltage on it needs to be refitted to terminal position n° 5. When you have correctly identified the wire coming from the docking switch (core n° 1) renumber this to terminal n° 4 and fit the wire to position n° 4 of the terminal strip
