Field tip # 22 Issued by Time Export, Denmark.

SUBJECT: Hydraulic levelling problem ETL with TECNORD single / Dual Inlet Valve

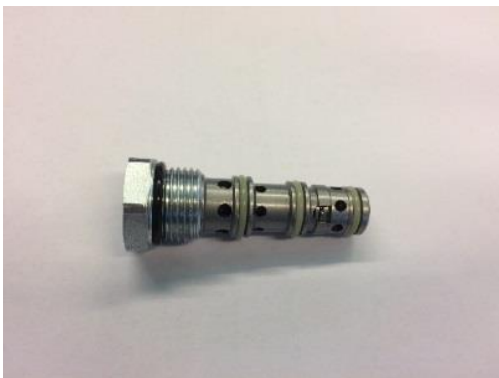
Cartridge valve 3070300-06
(Parts will be supplied by Versalift)

We have discovered a problem on some levelling systems operating on TECNORD valve. The problem is shown as the bucket/Gage is getting behind the function and after just one or two operations by the main boom. The reason for the problem is a cartridge valve with a leak. If you have a system with this problem then Versalift must be contacted, who will arrange for an Engineer to attend and replace the cartridge valve.
